## A Detailed Failure Analysis of Vertically Suspended Diffuser Pump Caused by Hex Head Bolt Fracture: The Marine Service Condition

Vertically suspended diffuser pumps play a significant role in the seawater cooling systems of the petrochemical and refinery industries. The present work deals with providing a detailed analysis of mechanisms involved in the early failure of hex head bolt used in the vertically suspended diffuser pump framework, which has served three years in the marine condition. The morphological and microstructural characteristics of the failed bolt were evaluated by optical microscope, scanning electron microscope (SEM), spark-optical emission spectroscopy (spark-OES), and X-ray diffraction (XRD) methods. Besides, a microhardness test was performed to assess the mechanical properties of the samples. The results demonstrated the presence of Cr, Fe, Mn, and Si elements in the microstructure of failed bolt, which coincides with the composition of stainless steel (X5CrMnN17-8). While there exist sulfur and oxide inclusions in the parts close to the surface, no surface-related defects were detected in the central part. Moreover, the microstructural assay showed that

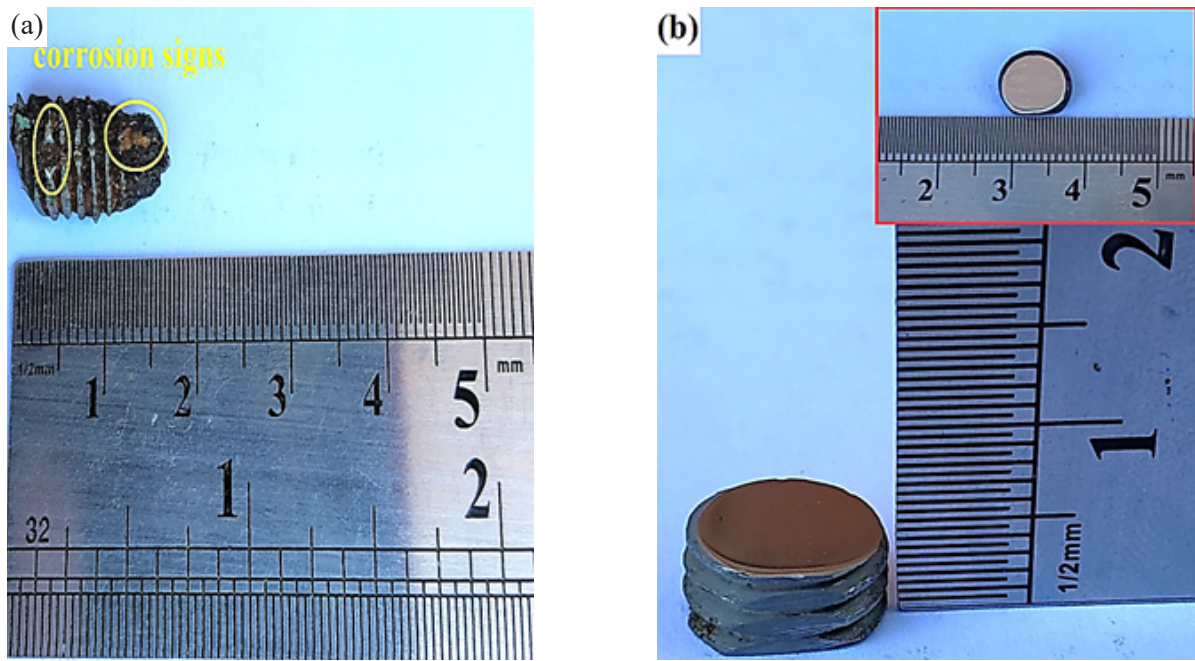
Fig. 3. (a) The optical micrographs of the as-received failed bolt and (b) the prepared cross-section for further investigations.

Fig. 3-a demonstrates that the bolt has been failed from the threaded side. Furthermore, there are corrosion signs on the surface of the failed bolt, as indicated by yellow circles. It worth mentioning that the corrosion attacks have no remarkable contribution to the bolt failure. The failure of the studied bolt not only took the VS1 pump out of service but also caused the failure of the other components of the pump, including split ring and shaft coupling. The prepared cross-section (Fig. 3-b) was mechanically polished using (#80-5000 grit) SiC emery papers followed by a final polishing via 0.3  $\mu\text{m}$  alumina

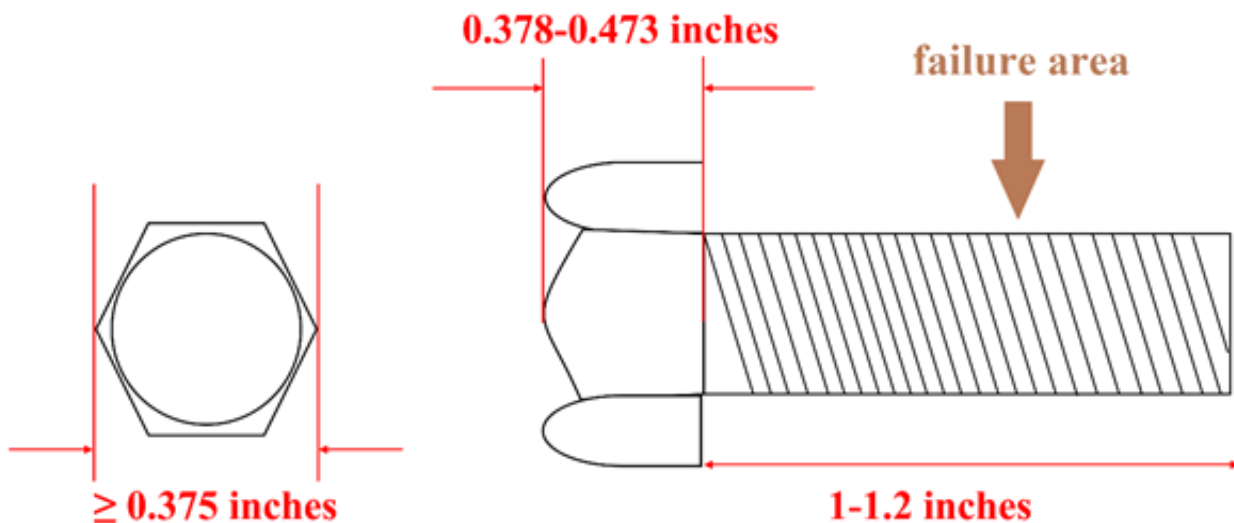
Fig. 4. Schematic illustration of shape and dimensions of hex head bolt, as well as the failure region.

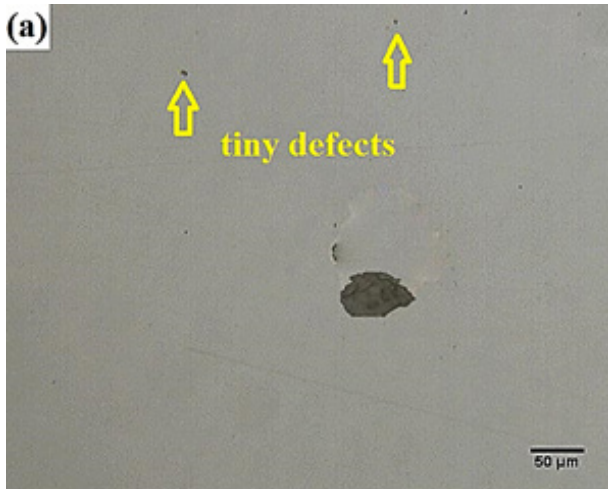
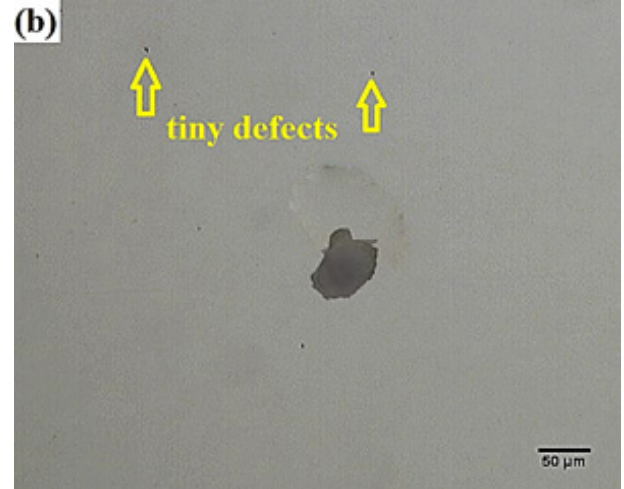
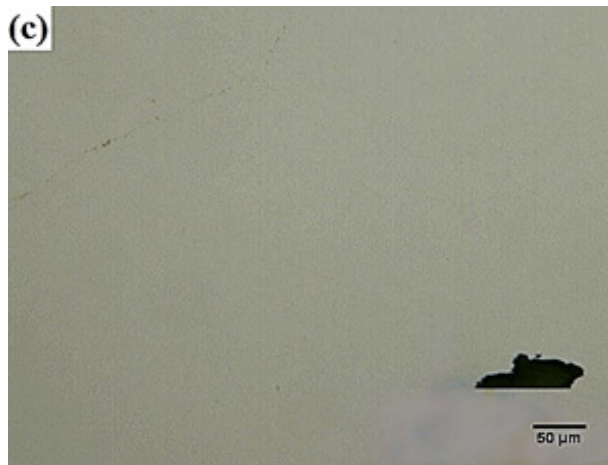
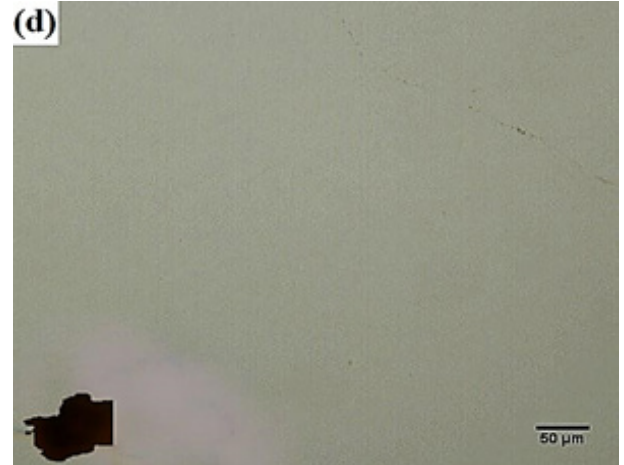
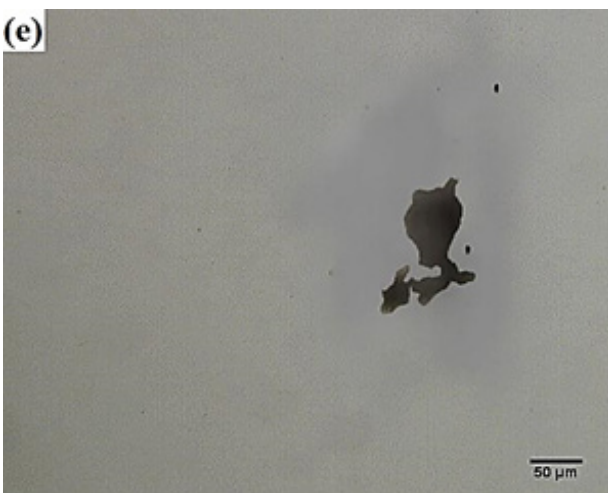
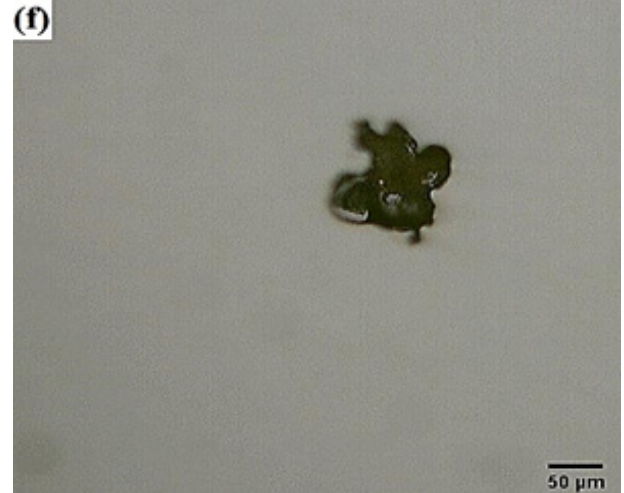
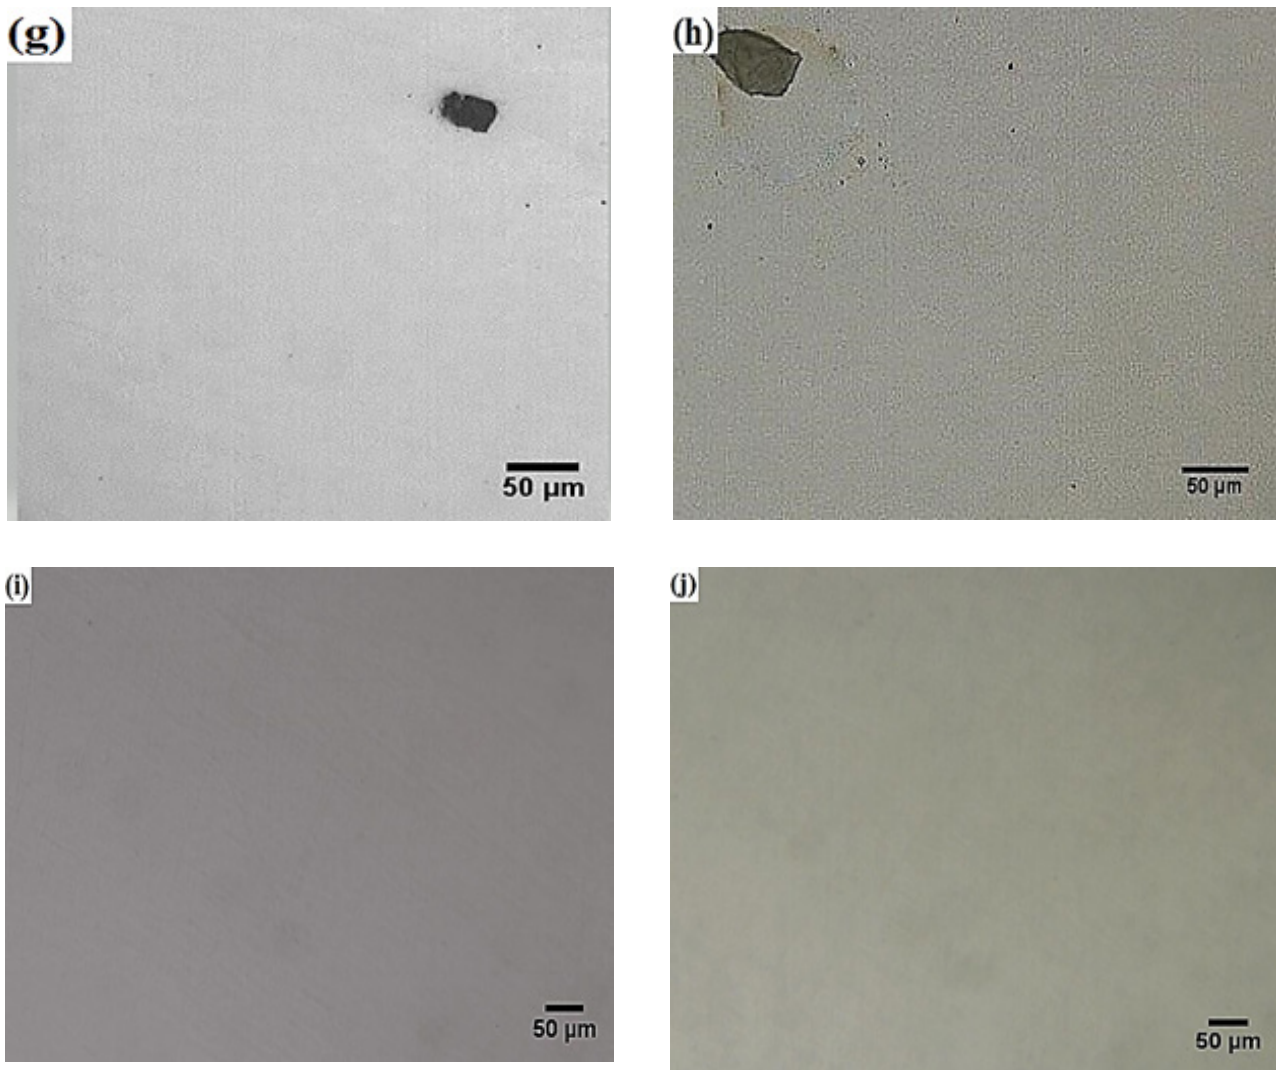
Fig. 6. The optical micrographs of various parts of the cross-section after polishing: (a, b): part 1, (c, d): part 2, (e, f): part 3, (g, h): part 4, and (i and j): part 5.

The obtained micrographs in Fig. 6 (a-h) offer that the parts close to the outer surface of the bolt possess micrometric inclusions that are dispersed over the surface. Furthermore, there can be seen some coarse cavities (50-100  $\mu\text{m}$ ) in these parts. Unlike the parts close to the outer surface, a defect-free surface is observable in the central area of the cross-section (see Fig. 6-i and 6). There are a low number of inclusions throughout the microstructure of the studied sample. However, synergistic effects of martensitic structure and large size of the present inclusions ( $>50 \mu\text{m}$ ) can promote the crack initiation and propagation in the outer surface of the bolt (parts 1-4). Besides these large inclusions, there are also tiny defects observable in OM micrographs (showed by arrows).

Turning again to Fig. 6, it seems that some of the observed cavities can be related to probable detachments that occurred around the inclusions. These voids may be generated because of mechanical polishing<sup>30</sup>. Table 2 shows the EDS analysis results of the prepared cross-section.

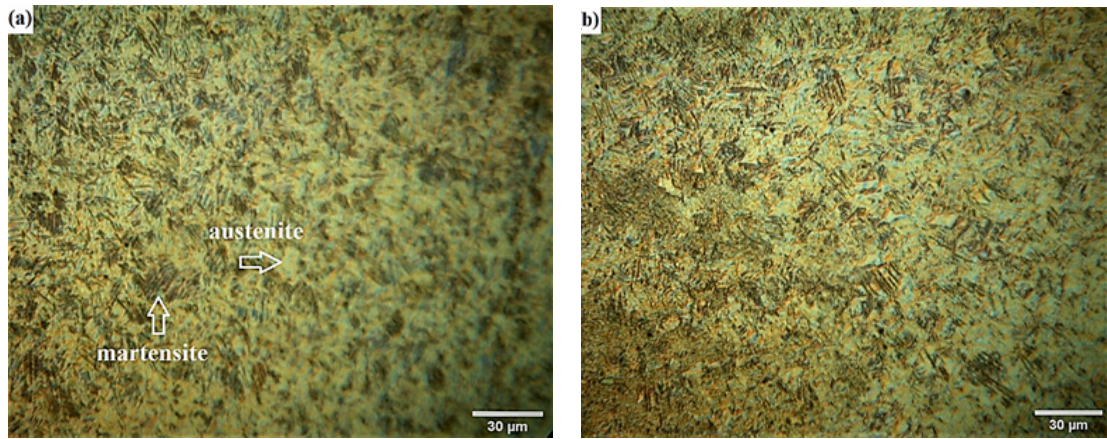
Fig. 7. The etched micrographs of two different parts of the cross-section specimen: (a) part 3 and (b) part 5.

The matrix in both studied parts composed of austenite phase and the martensite blades are dispersed over matrix. A comparison between the presented micrographs demonstrates no remarkable difference in terms of grain size in central and near-surface parts. However, the content of martensite in the outer surface is higher than that of the central part. These findings suggest that controlled thermal and mechanical treatments have been carried out on the bolt, which resulted in a uniform microstructure. SEM images of cross-section specimen

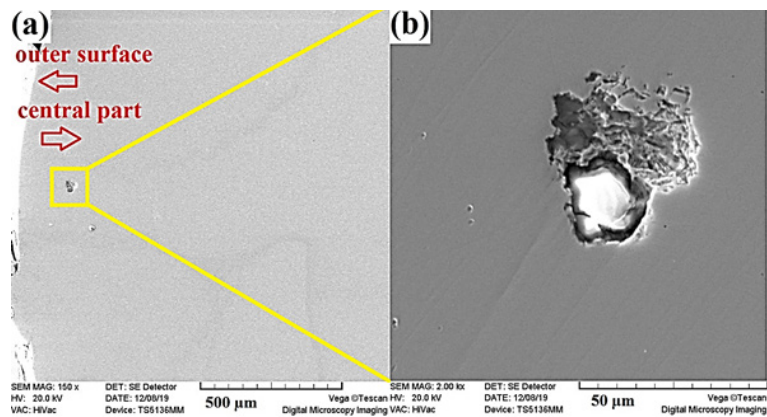
Fig. 8-a shows no defects in the central part of the cross-section, while some defects are formed in the parts close to the outer surface, as shown in Fig. 8-b at the high-resolution.

Fig. 8. SEM images of cross-section specimen at different magnifications: (a) 150X and (b) 2000X.

Although EDS is a semi-quantitative method for determining the amount of constituent elements in a given surface <sup>31</sup>, the results are well consistent with the spark-OES data except for Mn. EDS data of the inclusion showed in Fig. 8-b is provided in Table 3.

The analyzed inclusion is mainly composed of O, Cr, Fe, S, and Mn elements. It has been demonstrated that different non-metallic inclusions, such as  $\text{Cr}_2\text{O}_3$ , MnS, and  $\text{SiO}_2$  can be detected in the structure of the various grades of stainless steels <sup>32</sup>. These undesired compounds may be formed during the alloying process in the melt state. Hence, there should be precise control over the furnace atmosphere, charge materials,

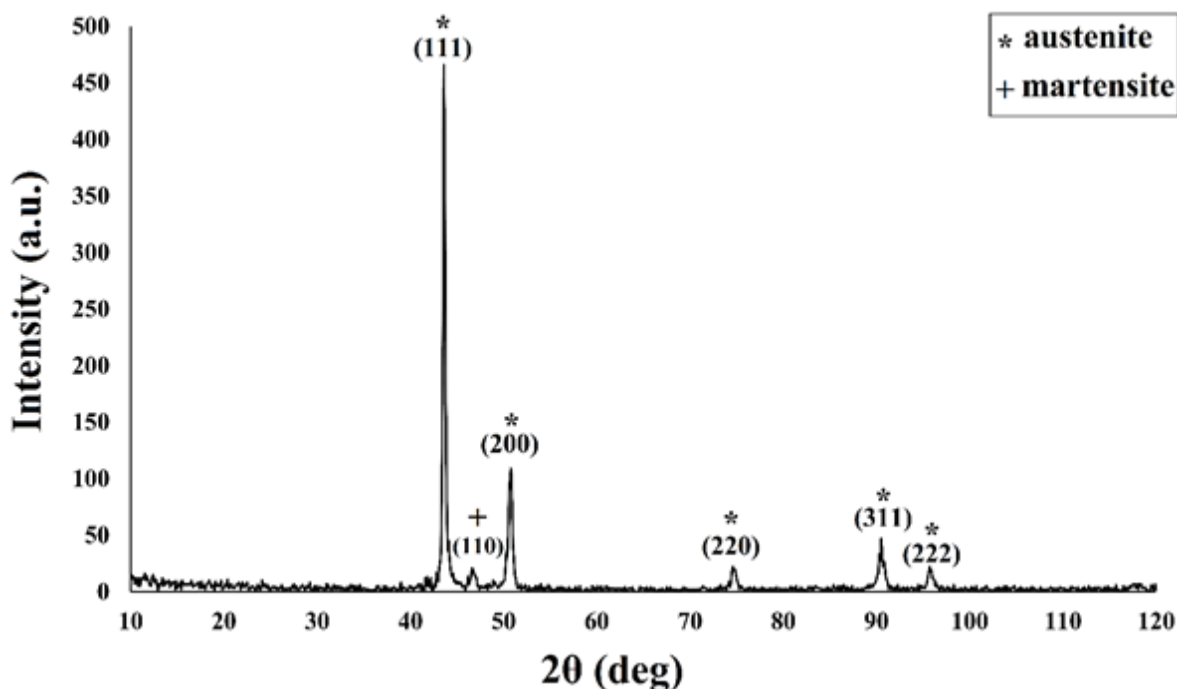
The obtained spectrum indicates that the microstructure of the studied specimen contains austenite and martensite phases. The (111), (200), (220), (311), and (222) crystallographic planes of austenite phase as well as (110) plane of martensite at  $2\theta=46.6^\circ$  can be seen from the spectra. The results of the XRD spectrum are associated with those obtained from the morphological assay.

Fig. 9. XRD spectra of the prepared cross-section of the bolt.

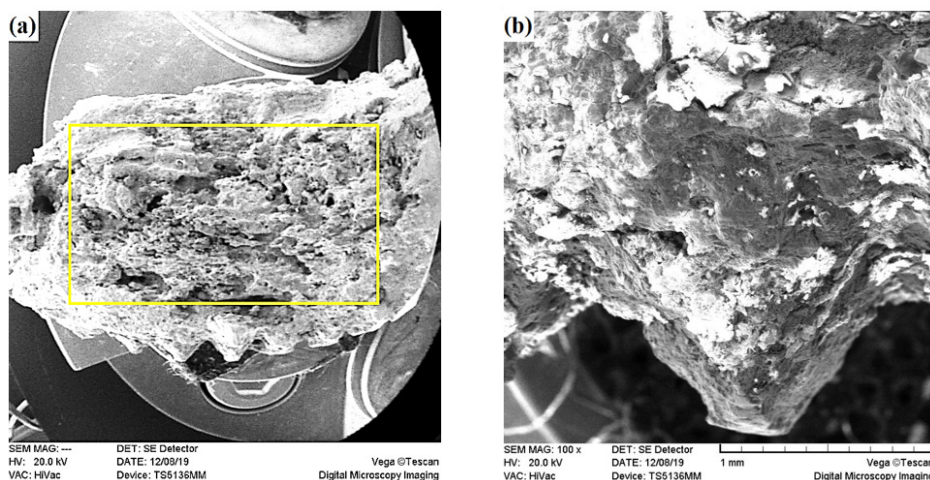
Fig. 10. SEM fractographs of the prepared cross-section specimen at two magnifications: (a) fish-eye image of the entire surface and (b) near-surface brittle fracture image. Yellow Square determines ductile fracture.

As seen in the fish-eye image, it is obvious that there are two different fracture mechanisms at various parts of the specimen. In other words, a flat fracture surface can be observed in parts 1-4, which assigns to brittle fracture. The formed oxide-sulfur duplex inclusions in these parts, namely close to the outer surface and bolt thread, are responsible for cracking in such a failure mechanism. Fig. 10-b provides a high-magnification image of occurred brittle fracture. The central part of the specimen, i.e., part 5, exhibits that ductile fracture has occurred with a sequence of void initiation, propagation, and link-up<sup>38</sup>.

- Controlling the chemical composition of the fabricated bolt to improve the mechanical properties and chemical stability in the service condition. In this case, modification of the chemical composition of the stainless steel by incorporation of Ni may result in promising outcomes as increasing the Ni content of stainless steel can increase its resistance to both corrosion and oxidation.
- Designing a favorable fabrication condition to pre-

vent the generation of pores and oxides in the microstructure of the bolt.

- Tightening-induced tensile stress during the pump mounting should be controlled. It is well known that the synergistic effects of tightening-induced tensile stress and corrosive medium can facilitate the corrosion process. Using the machining technique for bolt threads may lead to a similar problem.
- Surface modification of the fabricated bolt by suitable methods. Notably, the entire surface of the bolt should be uniformly coated by a crack-free coating since pitting and/or localized corrosion may be initiated if there was an un-coated area over the surface.
