# Microstructure and Mechanical Properties of Service-Exposed HP-MA Heat-Resistant Steel Tube, Used in Cracking Furnaces

## Abstract

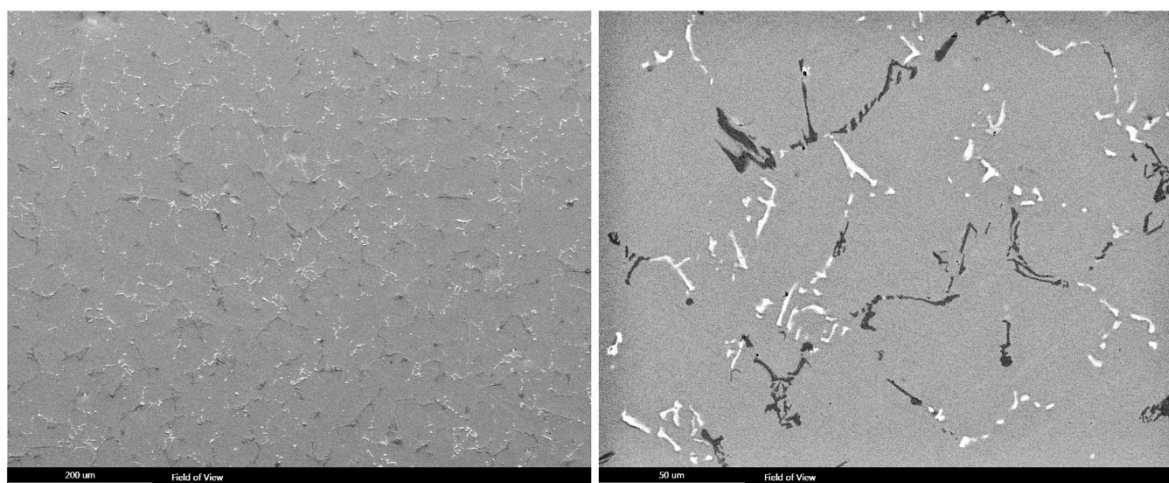
Fig. 1 shows microstructure of the as-cast heat-resistant specimen, before service exposure. In the image taken from the cross section of the sample, austenitic background and primary skeletal M<sub>23</sub>C<sub>6</sub> carbides at grain boundaries, where M comprises Fe and Cr, can be seen.

Fig. 1. Typical SEM micrograph of as-cast HP-MA alloy.

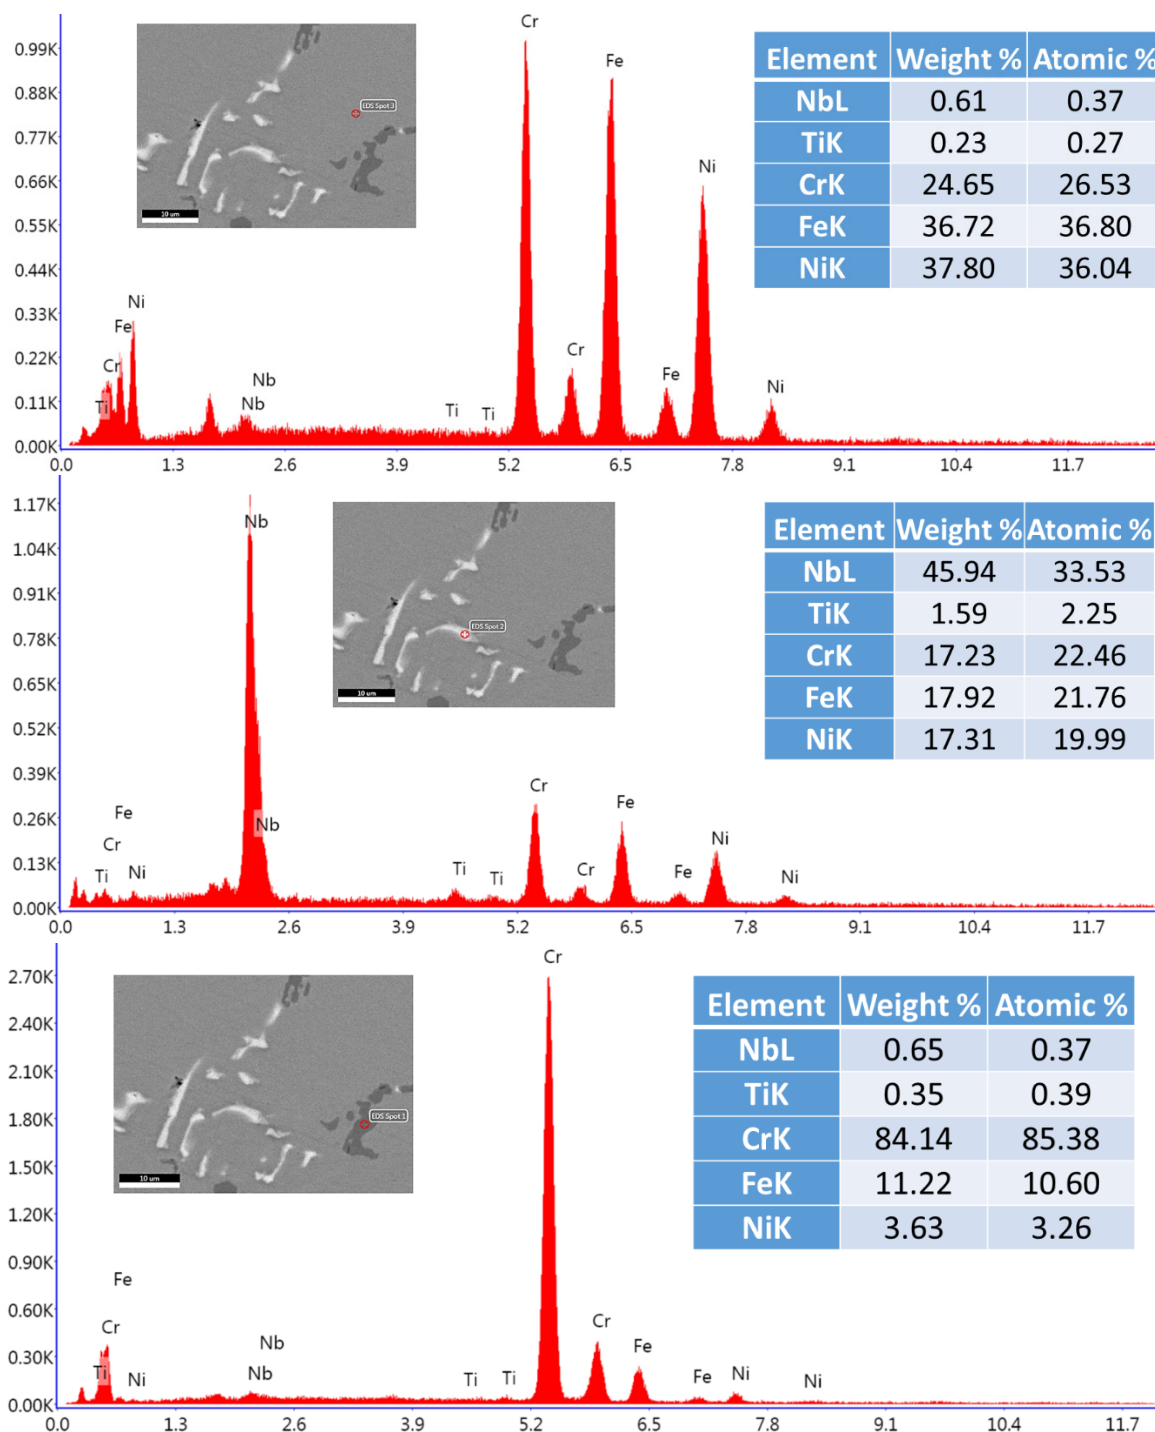
Fig. 2 depicts EDS analyses of different phases in the as-cast specimen. The white phase in this structure is rich in Nb, which can be concluded it is a niobium carbide phase. The grayish phase, on the other hand, is rich in chromium, inferring that this phase is a chromium carbide phase.

Fig. 2. EDS analyses of different phases: the matrix, the white phase and the grayish phase in the as-cast structure.

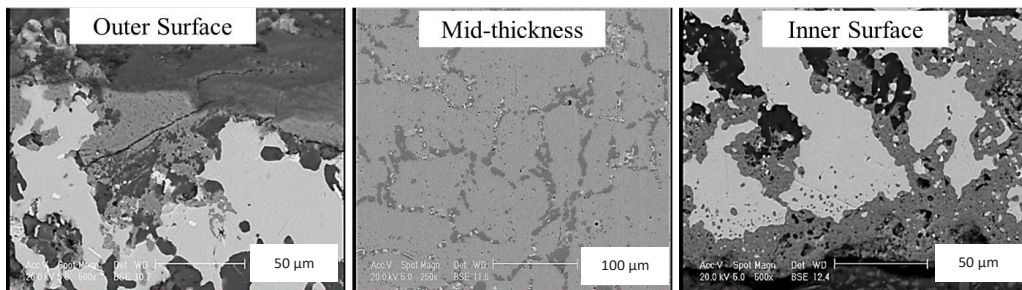
Figs. 5 and 6 depicts SEM micrographs of aged samples, after 20000 and 45000 hours of service. Again, these micrographs show how the structure at both inner/outer surfaces are degraded. In fact, the protective layer of chromium oxide ( $Cr_2O_3$ ) on the surface is an extremely important feature of this alloy, as it prevents the penetration of oxygen and carbon and other harmful elements towards the bulk structure. It appears that service exposure has severely degraded the mentioned protective layer, meaning that the surface structure can no longer resist the penetration of carbon. The fact that Si-rich oxide phases (black phases, see Fig. 7a) have been formed is an indication that the surface and internal oxidation reactions have become active at the early stage of service and operations. EDS results show that while Si-rich oxides are more formed further away from the surface, Cr-rich oxide phases (grayish phase, see Fig. 7b) are observed as a rather thick and porous layer at the surface. This pos-

Fig. 5. SEM microscope images of the sample after 20,000 hours of service.

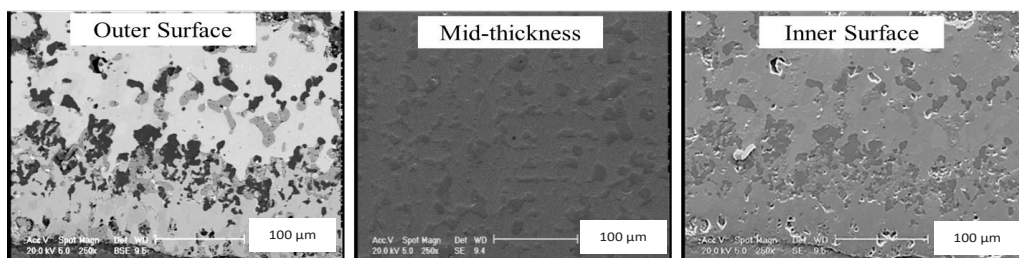
sibly has to do with the difference in the diffusion rates of Cr and Si. This mentioned service-originated Cr-rich oxide layer is typically very porous and in some areas it is further developed to the bulk of the alloy. As a result, the diffusion of carbon into the structure becomes easier, resulting in the carbide coarsening and formation of secondary carbides. The former phenomenon leads to a decrease in high temperature mechanical properties, more specifically creep resistance. The penetration of carbon into the substrate is associated with carburization, and therefore matrix hardening. In order to regenerate the degraded  $Cr_2O_3$  layer, the existing chromium in the matrix diffuses towards the surface, resulting in the formation of Cr-depleted areas near the surface. On the other hand, inside the tubes, there is oxygen that has penetrated into the structure and formed dark oxides, which are shown in the inner surface images of the samples. For the sample with 20000 hours service life, this surface layer has a thickness of 250  $\mu m$ , while in sample with 45000 hours service life, this thickness has increased to 450  $\mu m$ .

Fig. 6. SEM microscope images of the sample after 45,000 hours of service.

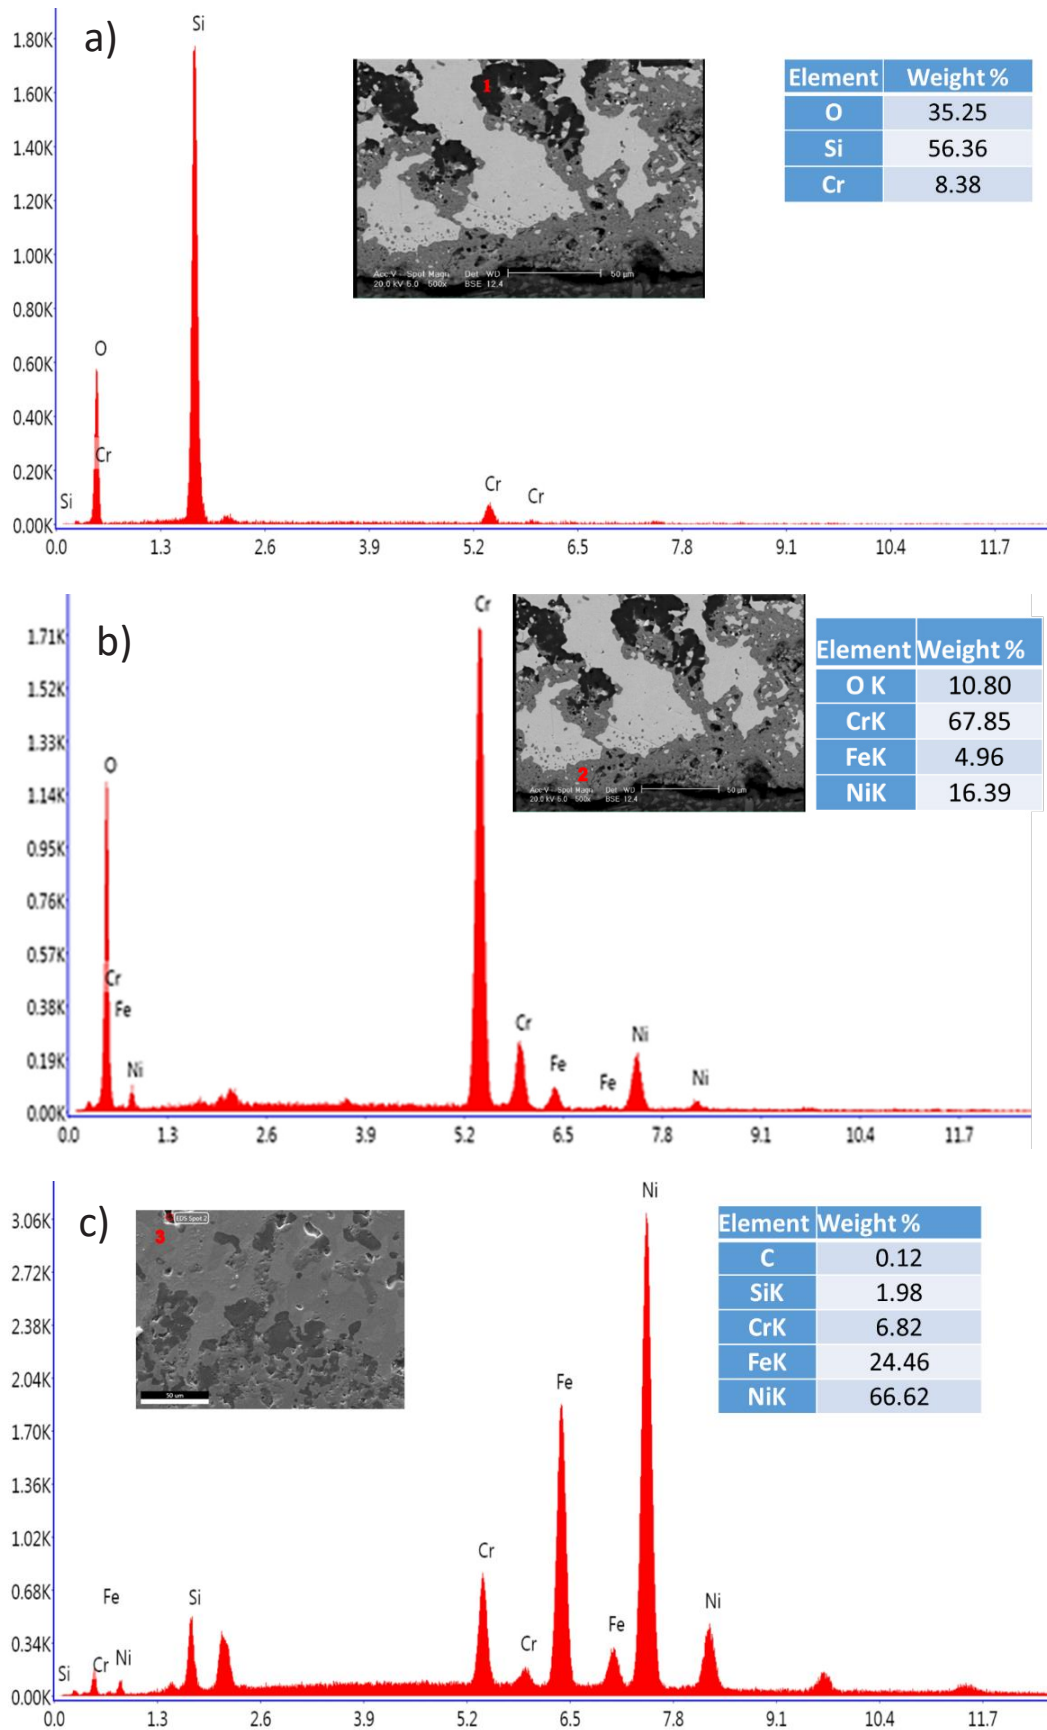
Fig. 7. EDS analyses of a) black phase, b) grayish phase, and c) the matrix in aged samples.

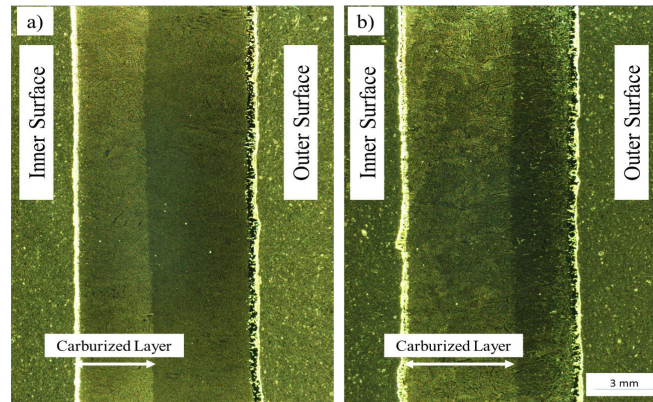
Fig. 8 depicts macro images of the cross-section of the tube after 20000 and 45000 hours of service. The color difference is attributable to the carburized layer. The lighter area is the carburized layer. Fig. 8 shows that the higher the ageing time, this thicker is the carburized layer is, such a way that in 45000-hour aged specimen, almost 70% of the total thickness is carburized.

Fig. 8. Macro images of aged tubes, after a) 20000 hours and b) 45000 hours of service exposure.

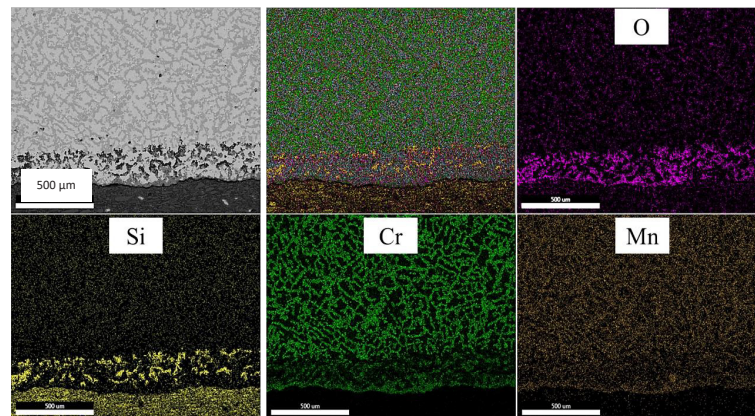
Figs. 9 and 10 depict elemental mapping at the inner and outer surfaces of the 20000-hour aged specimen, respectively. It appears that both the inner and the outer surfaces are heavily influenced by oxygen, as a thick

Fig. 9. Elemental mapping at the inner surface of the 20000-hours aged tube sample.

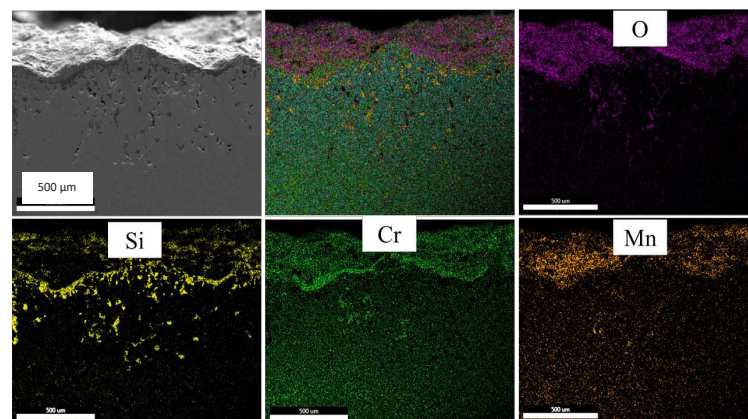
oxygen layer is seen at both surfaces. Also, it is seen that the segregation of Mn and Cr towards the surface is more pronounced at the outer surface, which has to do with more aggressive environment at the outer side of tubes. A heavily depleted Cr/Mn zone is also visible at the outer surface of the tubes. Another noticeable difference between the outer and the inner surface of the tubes, is morphology of silicon oxide phase. A distribution of rather fine globular silicon oxide particles are observed at the outer surface of tubes, while that is not seen in the inner surface.

Fig. 10. Elemental mapping at the outer surface of the 20000-hours aged tube sample.

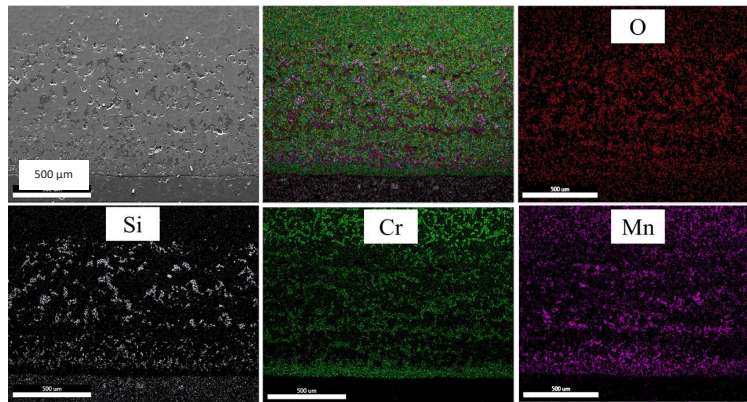
Figs. 11 and 12 depict elemental mapping at the inner and outer surfaces of the 45000-hour aged tube specimen, respectively. It is seen that longer service exposure from 20000 to 45000 hours is associated with the extension of surface-influenced layer. For example, the thickness of oxygen-rich layer at the inner surface has increased to values over 1000  $\mu\text{m}$  after 45000 hours of service, while that in the 20000 hours exposed tube is roughly 200  $\mu\text{m}$ . A comparatively more extensive Cr/Mn-segregated and depleted zones are also noticeable in this sample.

Fig. 11. Elemental mapping at the inner surface of the 45000 hours aged tube sample.

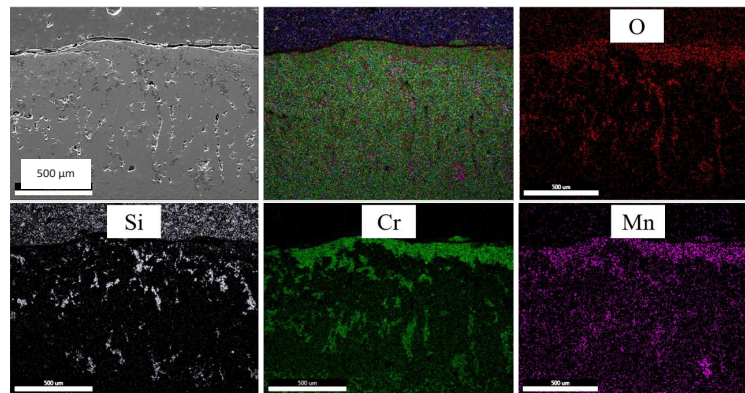
Fig. 12. Elemental mapping at the outer surface of the 45000 hours aged tube sample.

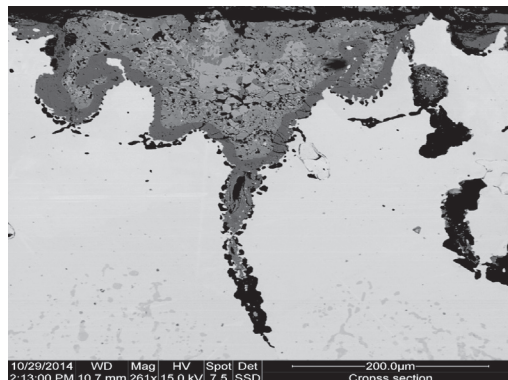
these oxide phases are rarely formed. In addition, because the inner surface of the tube is more exposed to carburizing gases, chromium, in particular, has a strong tendency to react with carbon and secondary carbides are formed in the structure. Due to the presence of oxygen in the furnace atmosphere, it can easily penetrate into the surface of the tubes and oxide phases are formed on the outer surfaces. Since around these oxide phases, it is a suitable place for formation of micro cracks, and network and continuous carbides have changed to separated carbides at a microscopic scale, according to the images, it can be concluded that oxide particles at the surface are preferential sites for the nucleation of micro-cracks. An example of a micro-crack, formed at the end of an oxide island is represented in Fig. 13. The micro-crack in this case is roughly 200  $\mu\text{m}$ .

Fig. 13. Micro-cracks, formed at the inner surface of service-exposed tube.

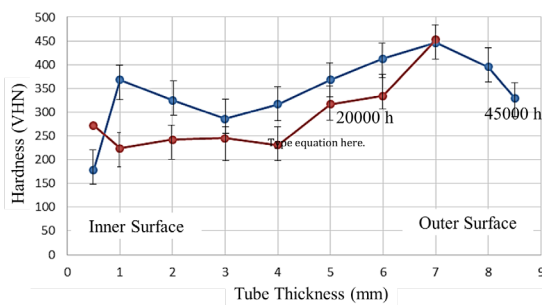
Vickers microhardness measurements for sample with 45000 hours of service, and sample for 20000 hours of service are shown in the Fig. 14. By comparing the present data, it is concluded that the sample with 45000 hours of service has higher hardness than the sample with 20000 hours of service because it had been exposed to carburization and oxidation for a longer period, associated with the formation of secondary carbides in the structure. According to this diagram, for the 45000 hours service-exposed tube, the hardness is significantly reduced in chromium-depleted areas. However, moving towards the middle thickness of the sample, the hardness gradually increases. 20000 hours service-exposed tube has less hardness changes through the thickness due to lower service time. With mentioning to say that, hardness differences through the thickness can be deleterious when it comes to thermal shock resistance.

Fig. 14. Microhardness of the tubes from inner surface towards the outer surface.
