Investigation of the Effect of the Efficiency of Catalysts on Early Destruction of Direct Reduction Reformer Tubes

Research & Development, Sirjan Jahan Steel Complex (SJSCO), Sirjan, Iran

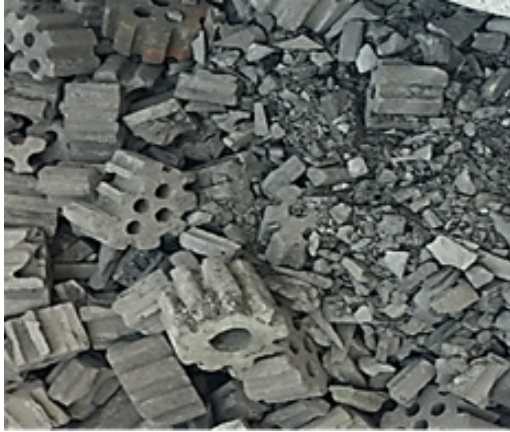
Fig. 2. Crushed catalysts discharged from the destroyed tube.

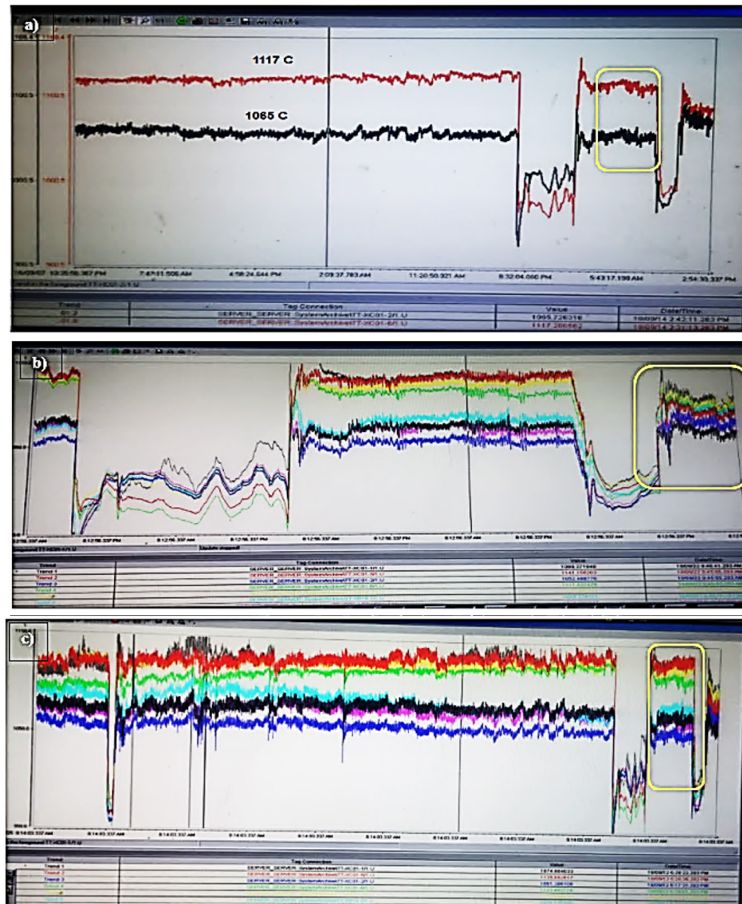
thermocouples. In recent months, it is observed that the temperature difference between two sides of the reformer's roof is about 50°C to 60°C; there is a similar difference, but lower compared to the ceiling, at the floor, and the reformer temperature is higher in the last bays (towards the stack) than the other parts. This difference is present in Fig. 3. Fig. 3(a) related to the two reformer thermocouples and their 3-day history. As can be seen, the temperature difference at the beginning of the diagram reaches about 50°C. Figure 3(b) shows all the thermocouples installed at the ceiling of the reformer weekly. As can be seen, the difference between the temperatures is significant; the same diagram is offered for three months in Fig. 3(c). The difference in the temperatures does not seem high at first, but then it increases. Therefore, the temperature on one side of the reformer (stack side) is generally 50°C higher than the other part. Accordingly, the second half of the reformer tubes (stack side) are at higher temperatures since all pipes have a relatively equal flow gas. It is well understood by observing the cleanout of the reformer so that the number of the hot tube from bey No. 7 to No. 14 is higher than the other parts. It should mention that there are some dark wall tubes in bey No. 1 to No. 7, which indicating they are cold.

Fig. 3. Graphs related to reformer ceiling temperatures: a) 3 days, b) weekly, and c) 3 months.

Hence, when the reformer temperature is kept constant, some reformer tubes are at higher temperatures, and their life is reduced. It is confirmed by the perforation of 3 of the reformer tubes in Bey No. 14 and the hot tubes observed in the second half of the reformer.

It is also extensively confirmed by the temperature changes of the reformer from Bey No. 1 to 14. Therefore, the reformer nozzles were cleaned entirely, and 38 mm orifices were utilized in rows 2, 3, 4, and 7 in the main torch one by one; on the other hand, in the parallel rows on the side of the stack, 33 mm orifices were employed. After starting the unit and normalizing it, the temperature difference between the two sides of the reformer decreased by 10 to 15 °C. It is shown well at the end of the diagrams (marked) presented in Fig 3. (a) to (c).

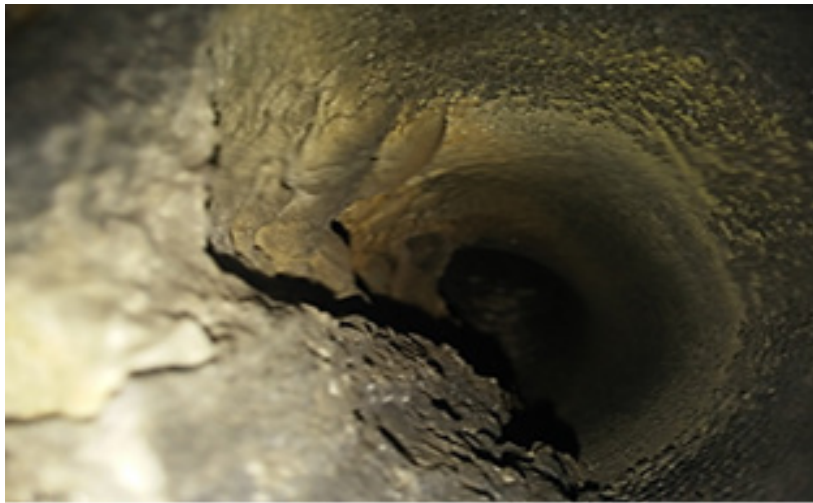
Fig. 4. Reformer main burner nozzles.

2) Since the return and its gas distribution are done from the furnace side, the gas used for fueling the burners is supplied from the return gas plus natural gas (if needed). Also, the return gas after passing through the upper scrubber carries some moisture and soft sponge particles with it. Therefore, the gas nozzles of the main burners may be clogged in the first bays. It was necessary to open and inspect the nozzles during the first monthly repairs. Figure 4 shows the open nozzles of the Bey No. 1 reformer. According to Fig. 4, sediment is formed in the reformer nozzles. This causes the nozzle to clog, the necessary flow for the burners to pass, and sediment deposition on the catalysts. By moving from Bey 1 to Bey 14, the clogging is reduced. Fig. 5 shows one of the selected nozzles in the reformer as an example.

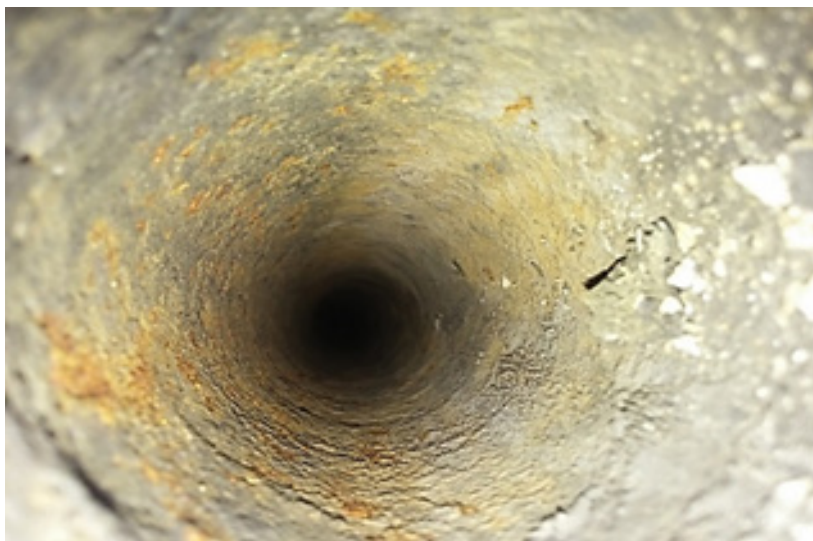
Fig. 5. The main burner nozzle in Bey No. 6.

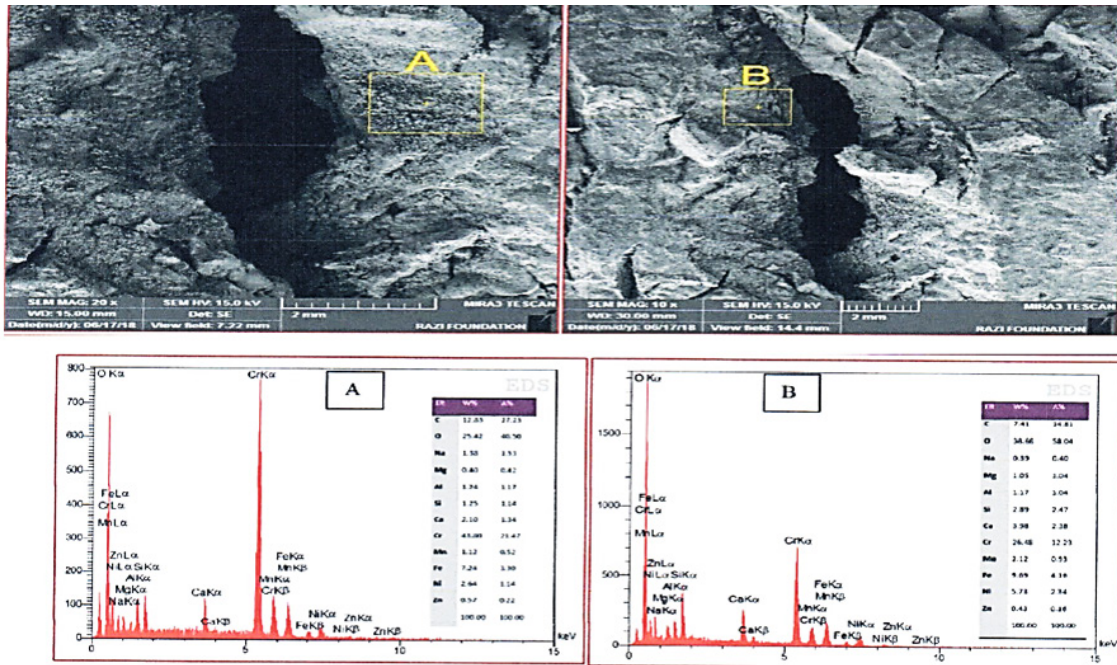
observed around the crack. Moreover, alkaline and alkaline earth elements were observed in the sample. For further investigations, the reasons for the destruction, the percentage of sulfur in the area close to the crack was measured using ELTRA carbon and sulfur measuring device after chipping; its value is equal to 0.1%, which is ten times the sulfur available in the alloy. Furthermore, the EDS results from the fracture surface confirm alkaline elements like sodium, resulting in hot corrosion in this area presented in Figs. 6 and 7. According to the working temperature of the segment, which is higher than 900°C, EDS results, and sulfur percentage, the destruction of the segment occurred under the influence of corrosion type I^{9,10}.

Fig. 6. Destroyed surface images with EDS analysis.

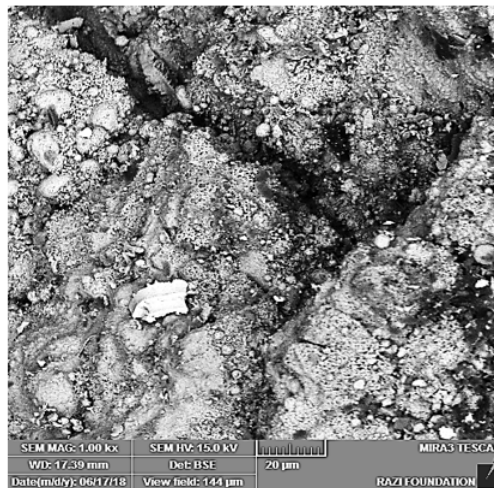
Fig. 7. Image of the failure area at higher magnification.
