An investigation on the fracture of 70Cr₂ steel balls during a grinding process and water quenching

A. Bagheriyeh

Senior Technology Engineer of Ghaltak Sazan Co, Esfahan, Iran

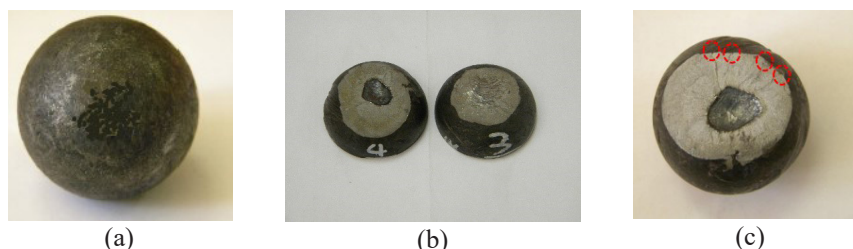
Figure 1 shows the samples experimented and the location of sampling in order to implement the tests. During the eye inspection of the destructed samples, it

was observed that the surface fracture of the destructed sample was a combination of a shiny surface with wavy lines and a rough one. Besides, the stress concentration points (red circles in Fig. 1c) are observed in the fracture surface, indicating the nucleation of initial cracks in the outer surface of the ball. In the center of the fracture surface of one of the fractured surfaces, a part of the outer surface of the sample is detected, representing a rough surface and an incomplete and a non-integrated sphere of the ball. According to the fracture surface, it is detected that the surface of the ball is separated in the form of a skullcap in such a way as to occur the scaling phenomenon. The outer surface of the destructed ball has some stress concentration points, and the periphery effects initiated from the forging process are apparent. The fracture surface of the destructed ball was investigated by a stereomicroscope. On the word of Fig. 2, the center of the fracture surface has a wavy appearance, revealing the unstable growth of the crack, which is originated from the brittleness of the structure, under the influence of applying an impact force; the direction of these waves shows the direction of the crack growth. There are some cracks on the fracture surface, starting from the outer surface of the ball, and a number of them advanced to the central part of the ball and have no uniform shape. The results related to the chemical analysis from the core of the fractured and sound samples, as well as the standard chemical composition are presented in Table 1.

Fig. 1. The cut cross-section of (a) the sound samples, (b) the fractured samples, and (c) red circles indicate the stress concentration points in the fractured ball.

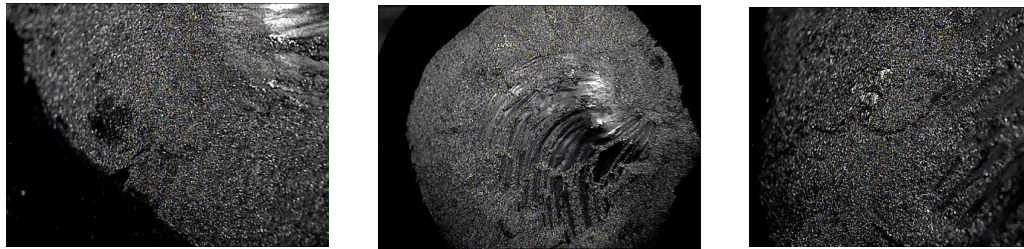
Fig. 2. fracture surfaces.

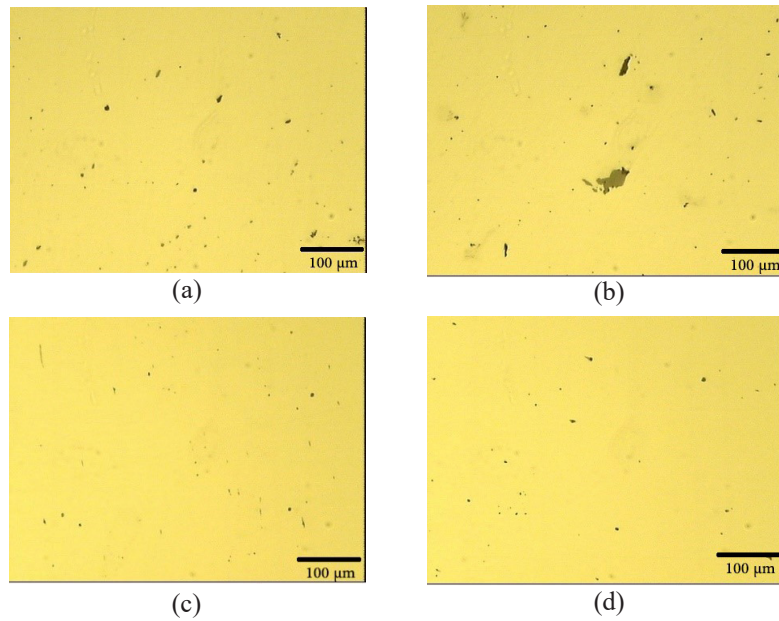
In the two destructed and sound balls, MnS and oxide impurity particles are detectable as gray and black colors in the matrix, respectively. The size of the impurities at the center of the destructed ball is larger than the area close to the surface, and the number of them at the center is lower than the aforementioned area. As can be seen, some sulfide impurities are nucleated from oxide impurities available in the matrix. Moreover, in metallography images, lots of cracks were detected, which typically

Fig. 3. The optical microscope images of the impurities: (a) the surface of the fractured sample, (b) the core of the de-structed sample, (c) the surface of the sound sample, and (d) the core of the sound sample.

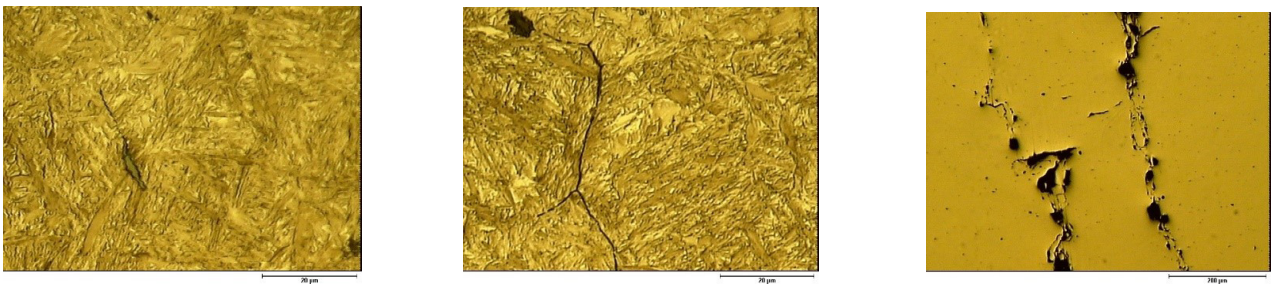
reach the surface of the sample. The cracks detected are in the form of branching in such a way that some of them have many branches. The origin of these surface cracks is attributable to a high cooling rate in heat treatment and the formation of a brittle structure, i.e., the presence of needle tempered martensite on the surface of the ball. The nucleation of the location of some of these cracks is impurities (see Fig. 4).

Fig. 4. The structure of the destroyed samples and impurities as the starting origin of a crack.

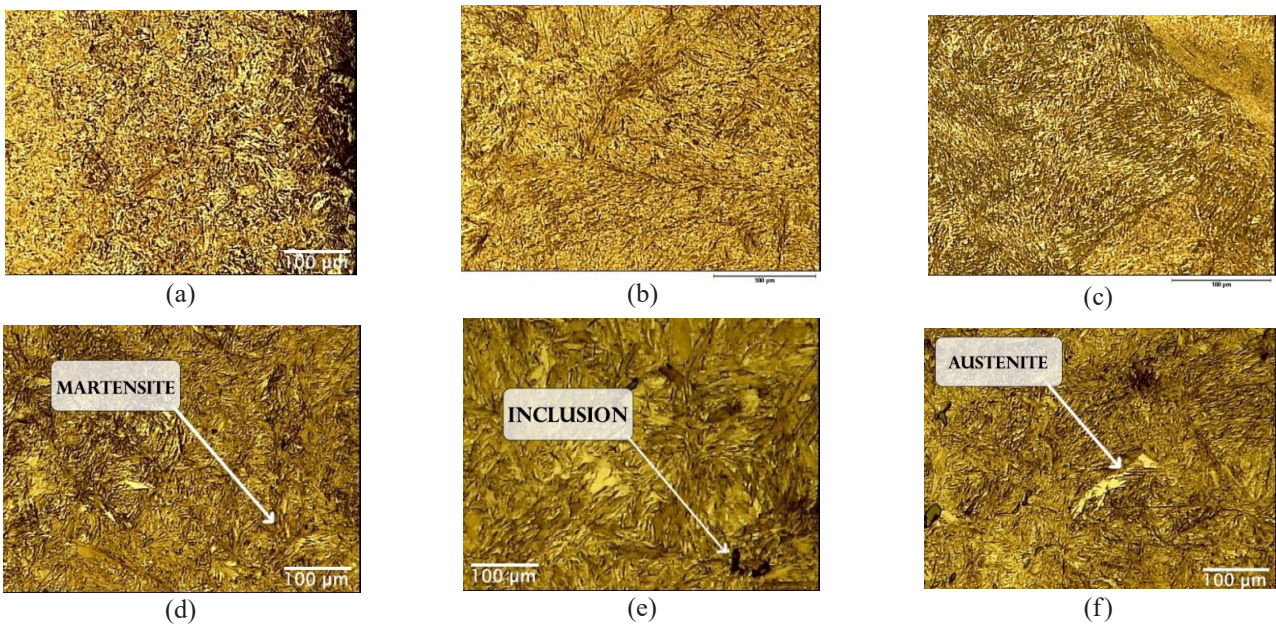
It should be noted that there was no crack in the sound sample. The origin of the subsurface cracks in the destructed ball is the applying impacts to the balls during the production process. In the destructed ball, the microscopic structure was the same all over the sample and included tempered martensite and residual austenite together with dispersed sulfide impurities. In the sound ball, the structure was mainly bainite with a little tempered martensite at the half of the radius, as well as tempered martensite on the surface of the sample. Furthermore, the structure in the destructed ball was rougher compared to the sound ball (see Fig. 5).

Fig. 5. The optical microscope images of (a) the surface structure, (b) the half of the radius, (c) the center of the sound ball, the structure of (d) the surface, (e) half of the radius, and (f) center of the destroyed ball.

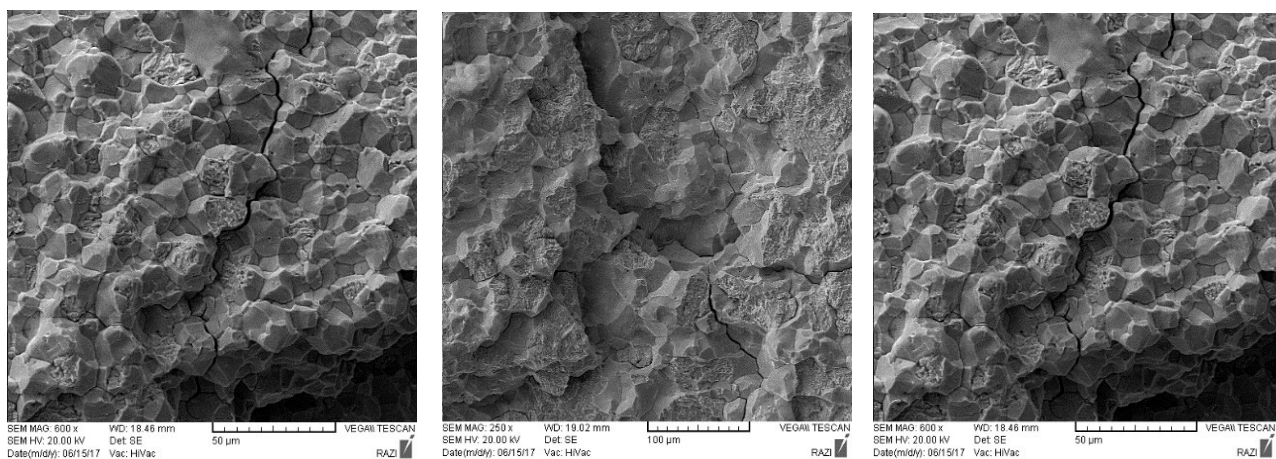
In the sound and destructed samples, a finer structure can be detected at the center of the sample compared to their surface. To complete the investigations, the fractography of fracture surface of the destructed balls was conducted with the help of a scanning electron microscope. The microscopic image obtained from the fracture areas is shown in Fig. 6. As can be seen, the surface at the starting and ending points is completely brittle and intergranular, and the microscopic and macroscopic cracks are observable in the grain boundaries. These observations are in accordance with the results of structural investigations and the presence of brittle martensitic structure of the ball. The presence of the intergranular fracture surface is an indication of the low fraction energy of the ball. Hence, it seems that the microscopic cracks are expanded easily with the first impacts. In the metallography images of the destructed sample, some cracks and stains were observed, indicating the brittle fracture surface with the help of SEM. It should be mentioned that the presence of the abovementioned cracks and stains shows the propagated cracks at the center of the ball. The impurities observed in the destructed and sound balls are sulfide (light gray color) and oxide (black color) compounds.

Fig. 6. The SEM images from the fracture cross-section of the destructed balls.

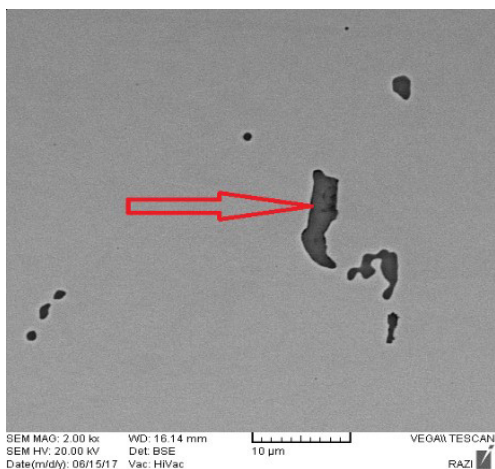
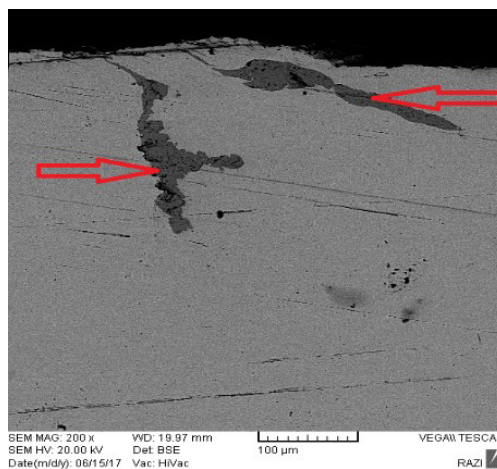
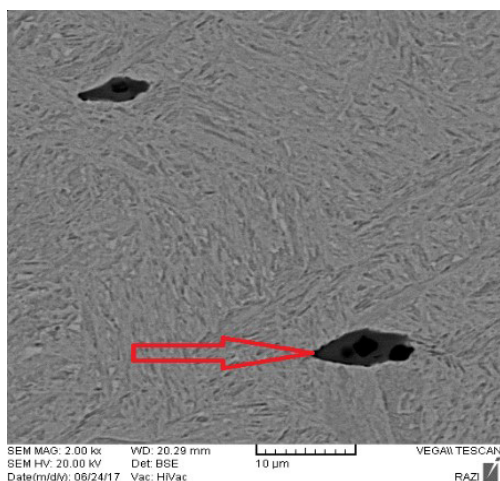
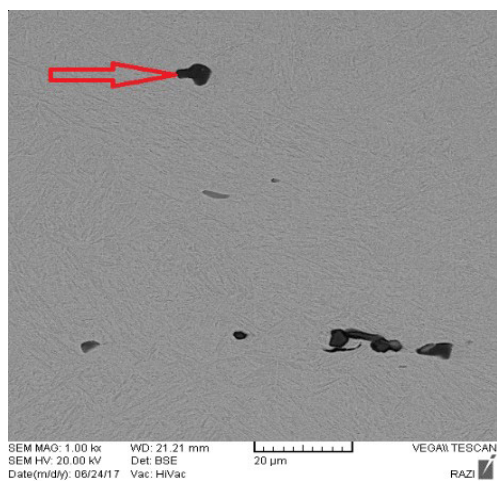
According to Fig. 7a and 7b, the oxide defects are observed at the center and underneath the surface of the destructed ball; the origin of the aforementioned defects is related to the deformation process of the sample (an incorrect deformation process and creating stress lead to the severity of the problems and the increase of possibility of fracture because a correct and precise deformation process eliminates the problems in keeping with the conducted studies). Similar to the fractured sample shown in Fig. 7c and 7 d, there are some oxide and sulfide impurities at the center and on the surface of the sound ball.

Fig. 7. The SEM and EDS analysis images of oxide and sulfide impurities: (a) the center and (b) the surface of the fractured ball, and (c) the center and (d) the surface of the sound sample.
