# Problems derivation and functionality enhancement of a double girder overhead crane for billet transmission: case study

## Abstract

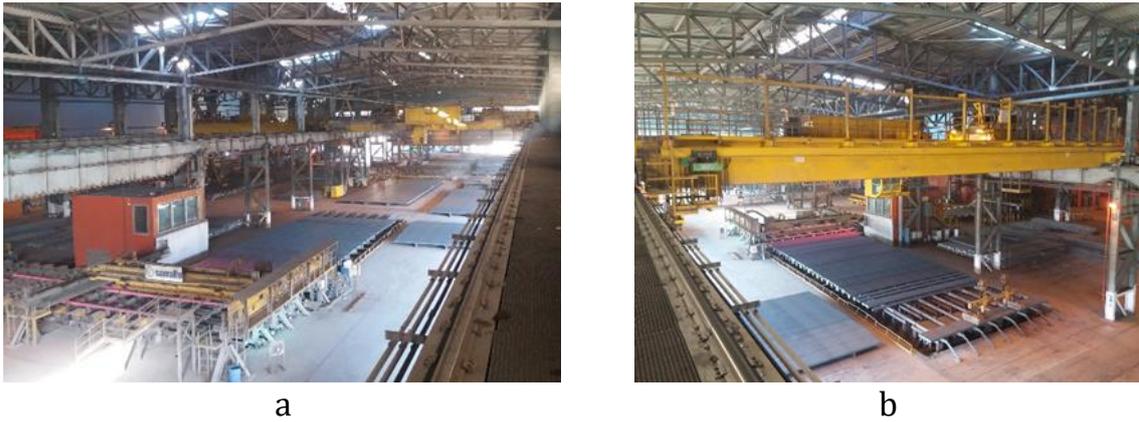
A view of the billet transport span in the South Kaveh Steel (SKS) company is shown in Fig. 1. The produced billets from the casting unit are placed on the walking beam employing the billet transfer car. These billets are hot and lose their redness at the end of the path on the pusher. The 30tone- double girder overhead crane removes the billets on the pusher and stores them at the end of the salon for transport and loading. This crane has encountered various problems in the last four years. Wear of the rail and crane, skew-

Fig. 1. The billet transport span in the SKS company a) South view b) North view.

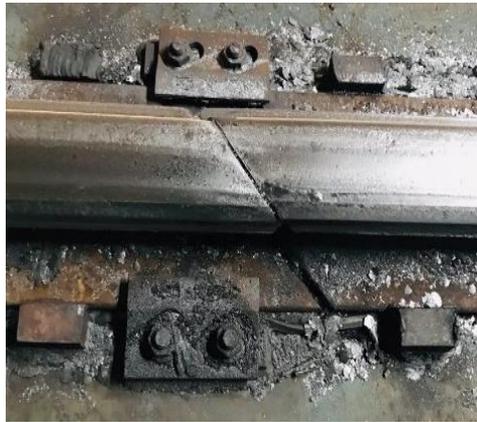
For solving the thermal stress that cause buckling and cracking, using the rail patch and expansion gap can be proposed. The longitudinal and expansion/compression forces are compensated using the rail gap in the crane paths. A sample of the rail gap attachment which is designed and installed in the crane rail of the SKS Company is shown in Fig. 11. The way of designing the gap between two rails, in millimeters, is shown in table 1.

Fig. 11. A sample of the rail gap attachment which is designed and installed in the crane rail of the SKS Company.

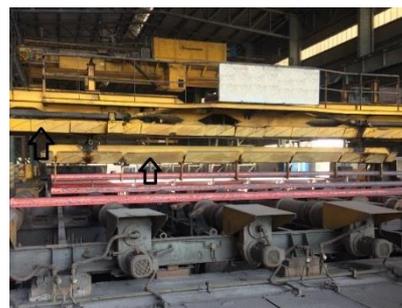
The heat shield and splash thermal insulation called the anti-fire covers, based on the rock wool, need to be used on the crane beam and columns at the hot billets location. These insulations are resistant to wear and cor-

rosion. In the design without the thermal insulations, the temperature at the middle and the entrance of the span was 100°C and 40°C, respectively and thus the temperature difference reached 60°C, which definitely interferes with the crane movement due to the rail expansion and contraction. In the designing with the heat shield and thermal insulation, these temperature difference is reduced significantly. Fig. 12a. and 12b show a kind of thermal insulation and heat shield, respectively. With a simple simulation and industrial trials, the temperature difference reduced from 60°C to 30°C which has a considerable effect on the displacement as illustrated in Fig. 8.

Fig. 12. a) Thermal insulation b) Heat shield.

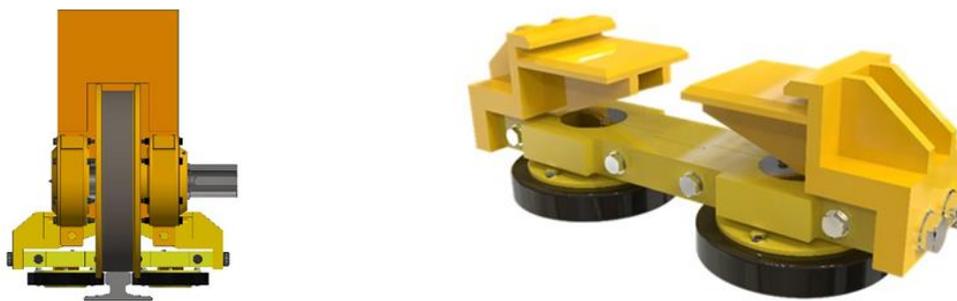
According to the mentioned various reasons, designing the rail guide was performed by the engineering group of the SKS company to decrease the contact between the existent wheel's edge and rail, and wear of them and also to provide easy and fast installation and repair. Fig. 14. shows the designed rail guide by the engineering, research, and technology group of the SKS Company. Fig. 15. shows the way of assembling the rail guide below the crane bogie.

Fig. 14. The designed rail guide by the engineering, research, and technology group of the SKS company.

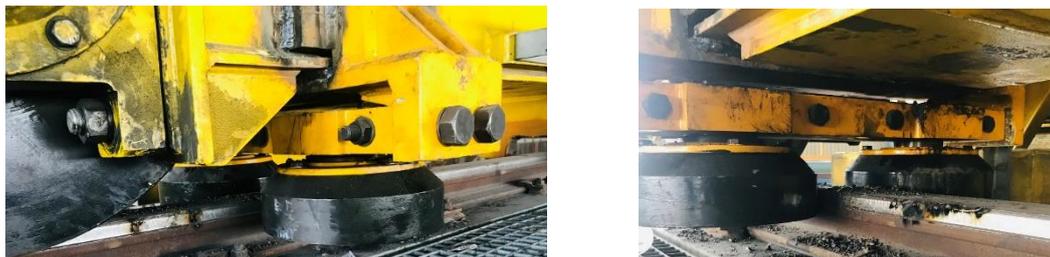
Fig. 15. The way of assembling the rail guide below the crane bogie.
