## A Detailed Failure Analysis of Vertically Suspended Diffuser Pump Caused by Hex Head Bolt Fracture: The Marine Service Condition

Vertically suspended diffuser pumps play a significant role in the seawater cooling systems of the petrochemical and refinery industries. The present work deals with providing a detailed analysis of mechanisms involved in the early failure of hex head bolt used in the vertically suspended diffuser pump framework, which has served three years in the marine condition. The morphological and microstructural characteristics of the failed bolt were evaluated by optical microscope, scanning electron microscope (SEM), spark-optical emission spectroscopy (spark-OES), and X-ray diffraction (XRD) methods. Besides, a microhardness test was performed to assess the mechanical properties of the samples. The results demonstrated the presence of Cr, Fe, Mn, and Si elements in the microstructure of failed bolt, which coincides with the composition of stainless steel (X5CrMnN17-8). While there exist sulfur and oxide inclusions in the parts close to the surface, no surface-related defects were detected in the central part. Moreover, the microstructural assay showed that

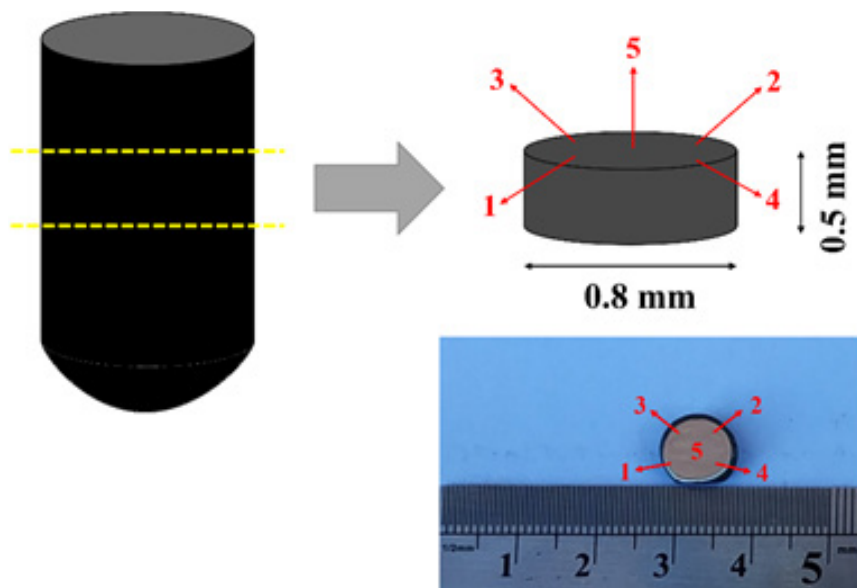
The surface area of the prepared cross-section was divided into five parts to study and compare the overall properties throughout the surface, as shown schematically in Fig. 5.

Fig. 5. Schematic illustration of the prepared cross-section that is divided into five parts. These numbers in the following text will denote the different parts of the cross-section.
