# The Effect of Erosion on Corrosion Protection Properties of Coal Tar Epoxy Coating

## Abstract

In this work, the effect of erosion on corrosion behavior of coal tar epoxy coating was evaluated using electrochemical impedance spectroscopy (EIS) measurements. The surface morphology of the coating was examined by scanning electron microscope (SEM) after 10, 20, 30, 45 and 60 min of erosion process at an impact angle of 90°. After 10 min of erosion process, the Nyquist plots showed just a single large capacitive semicircle and the phase Bode plots exhibited a line close to  $-80^\circ$  in the middle-frequency region, thereby indicating high corrosion resistance (about  $109 \Omega\text{cm}^2$ ). After 20 and 30 min of erosion process, the diameter of the Nyquist semicircle was decreased with time and two semicircles appeared after 45 min. Furthermore, SEM observations revealed that the protection performance of coating was decreased by an increase in time of erosion due to the formation of holes and electrolyte penetration into the coating. Finally, after 60 min of erosion process, the coating was partially removed and the substrate appeared.

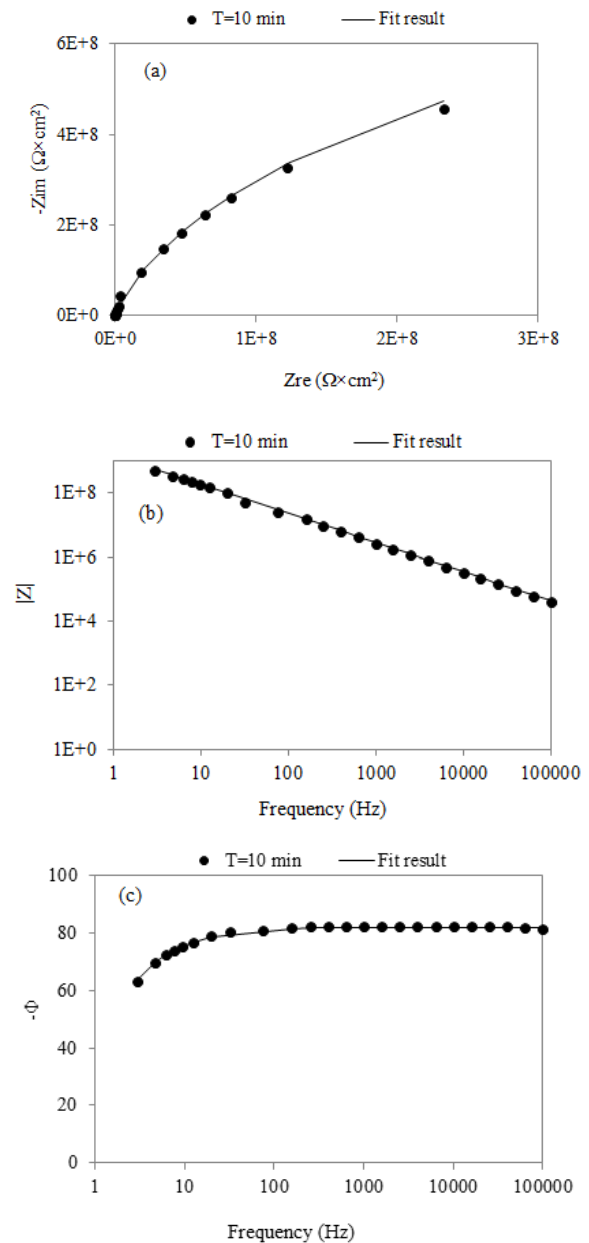
Nyquist and Bode plots of the coated specimens after 10 min of the erosion experiment are shown in Fig. 6. Nyquist plot showed a huge semicircle and the Bode plot represented a capacitance behavior, implying the high corrosion resistance of the coating. The impedance modulus  $|Z|$  at low frequencies

displayed very large values ( $>10^9 \Omega \text{ cm}^2$ ). The slope of  $Z-\log f$  curve was about  $-1$  and the phase angle was almost  $-80^\circ$  (Figs. 6b and 6c). A time constant could be observed from the impedance spectra responsible for the barrier characteristic of the coal tar epoxy coating<sup>12, 13</sup>. After 10 min, coating capacitance ( $C_c$ ) and pore resistance ( $R_{\text{por}}$ ) were about  $3.1 \times 10^{-10} \text{ F cm}^{-2}$  and  $1.5 \times 10^{+9} \Omega \text{ cm}^2$ , respectively. These data were related to the as-received coating, which had a very high corrosion resistance.

Fig. 6. Impedance diagrams of samples after 10 min erosion process in the form of (a) Nyquist, (b) Bode, and (c) Bode phase plots.
